# Assessment of Dam Safety

## Coal Combustion Surface Impoundments (Task 3)

Dayton Power &  
Light Company

JM Stuart Station

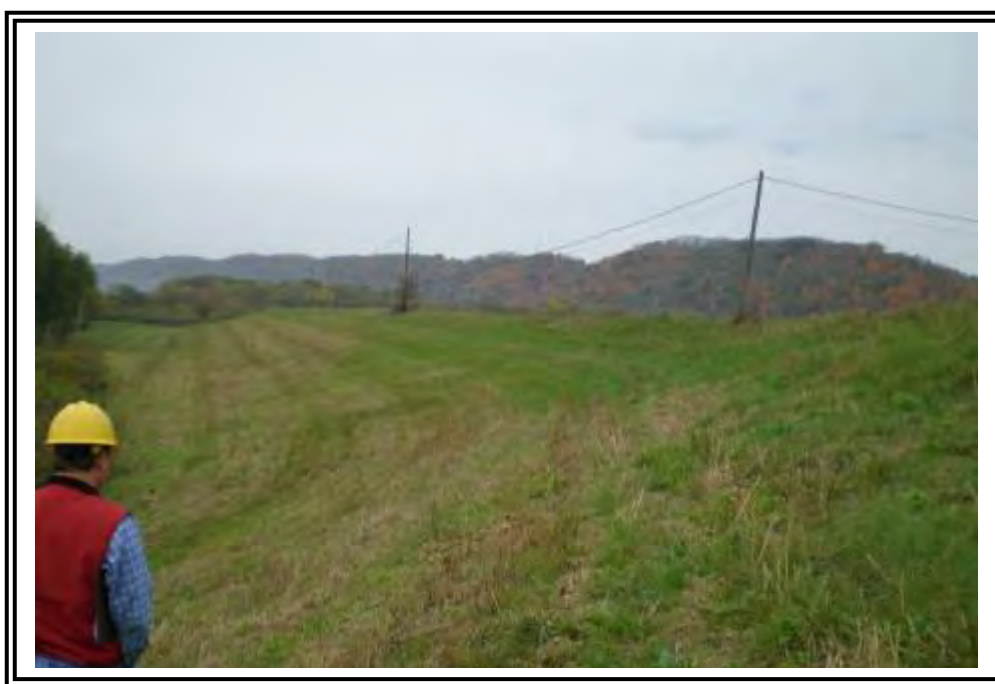
In general, the south dike (Photo 6) and the north dike (Photos 20 and 21) appeared to be maintained and mowed. However, seepage initiated slope softening and subsequent mowing induced rutting and slope deformation was observed on the downstream slopes of the dikes in at least four locations. One such area measured approximately 326 feet long approximately 52 feet from the toe with 6 to 12 inches of standing water (Photos 15 and 16). These areas often had heavier vegetation, scrub brush, and small trees established where routine tractor mounted mowing had not occurred for a fairly long period of time as a consequence of the softened slope conditions (Photos 11 and 12). In most cases however, these areas were generally covered with heavier grass and other weedy vegetation (Photos 10, 19 and 22)

Looking west along the downstream slope of the south dike.

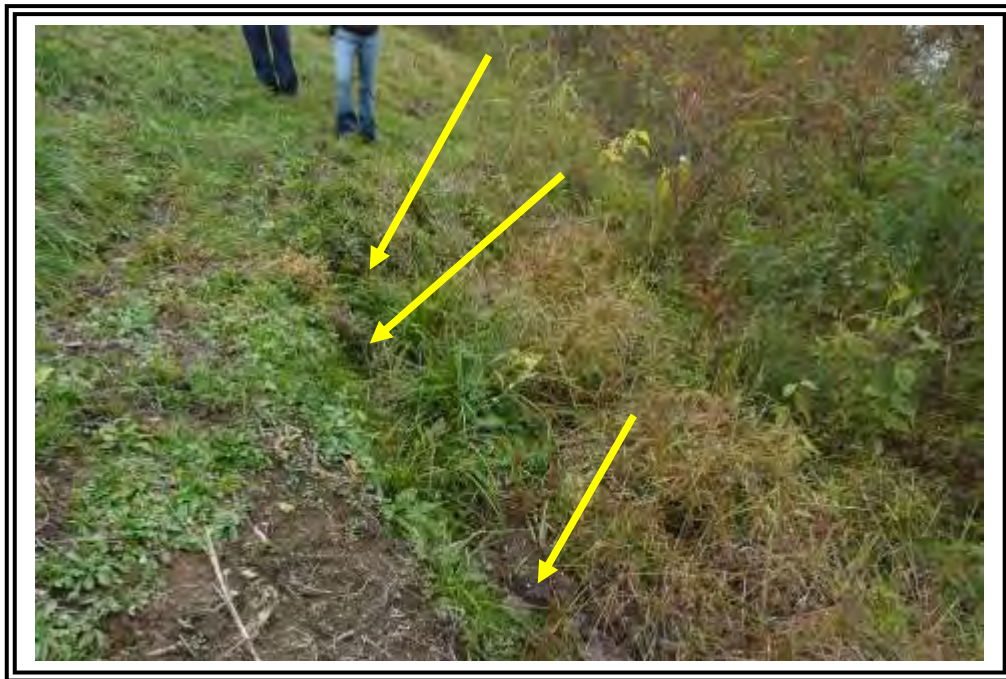
14

In addition to the seeps and resulting softened slope areas, scarp areas were observed on the south side of the pond and western extremity of the pond. A scarp on the south dike (Photo 13) occurred along a heavily vegetated, over-steepened portion of the dike adjacent to a haul road drainage ditch. It measured roughly 52 feet in length along the dike centerline. The scarp encountered on the west end of the pond measured approximately 30 feet in length and appeared to occur in a location of softer soil (Photo 14). Standing water was observed in this scarp and the soft soil in the area of the scarp it is likely the result of seepage at this location.

Vegetated scarp with standing water on west side of the pond. Approximately 30 feet long. (See arrows)

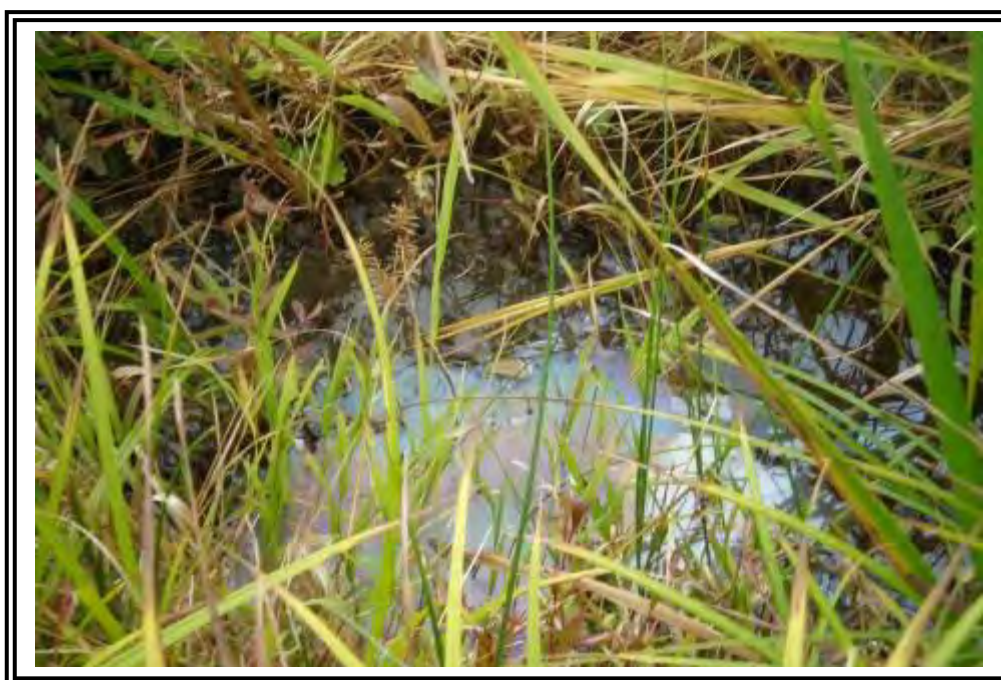
16

A close up of a larger seep with a sheen on the surface.

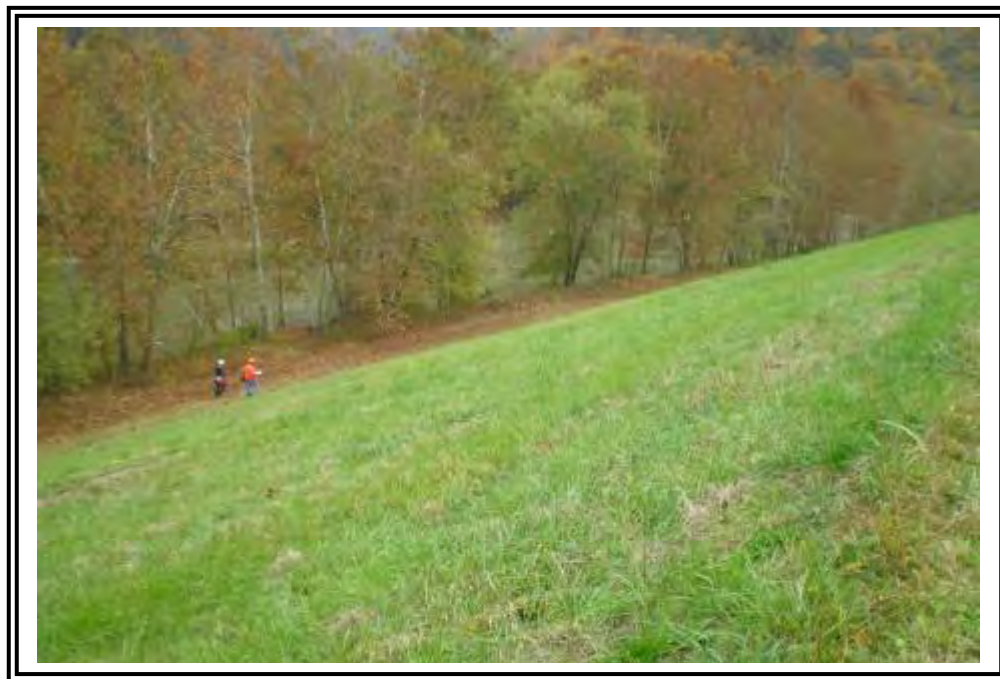
20

Looking northeast along the downstream slope of the northern dike.

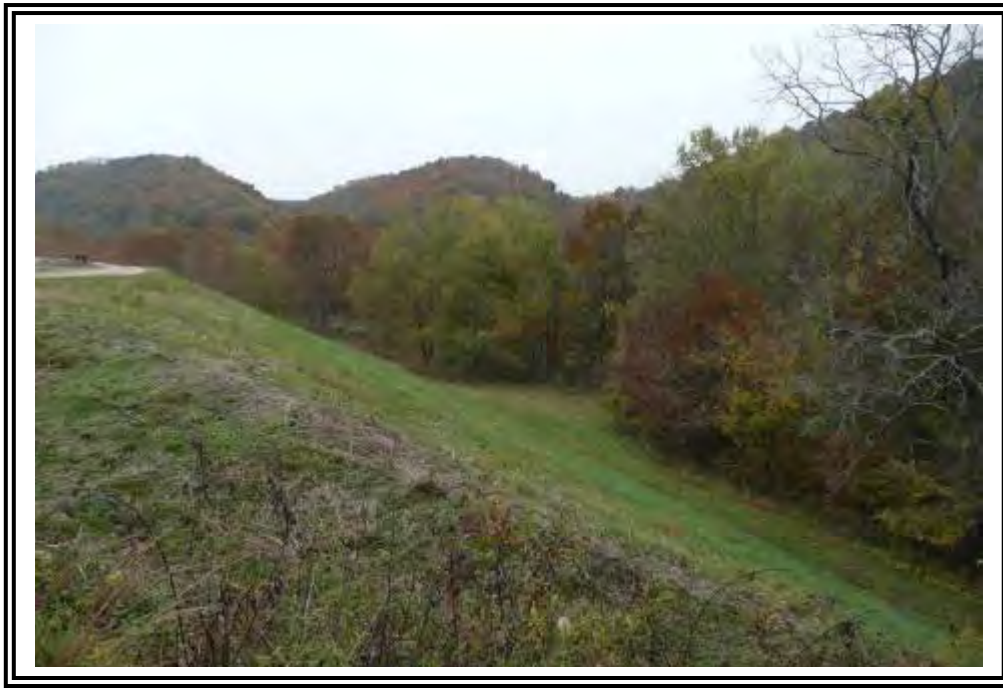
21

Looking west along downstream slope of the northern dike back toward the west end of the pond.

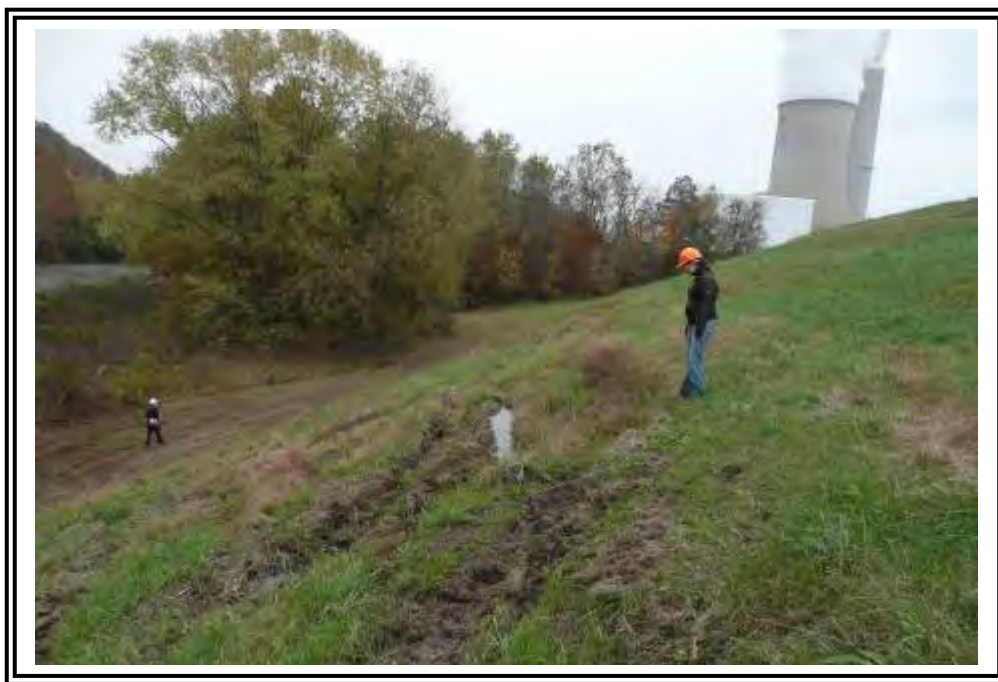
22

Looking east at the downstream slope of the northern dike near the middle of the pond where some seepage, subsequent softening, and slope deformation due to rutting has occurred.

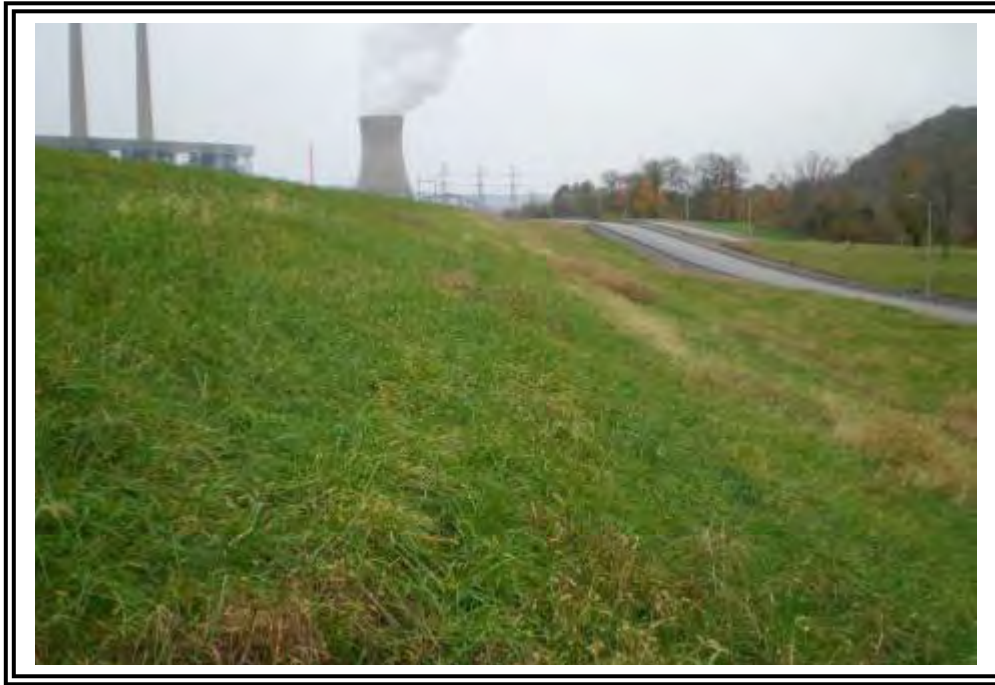
31

Looking southwest along the downstream slope of the northern dike.

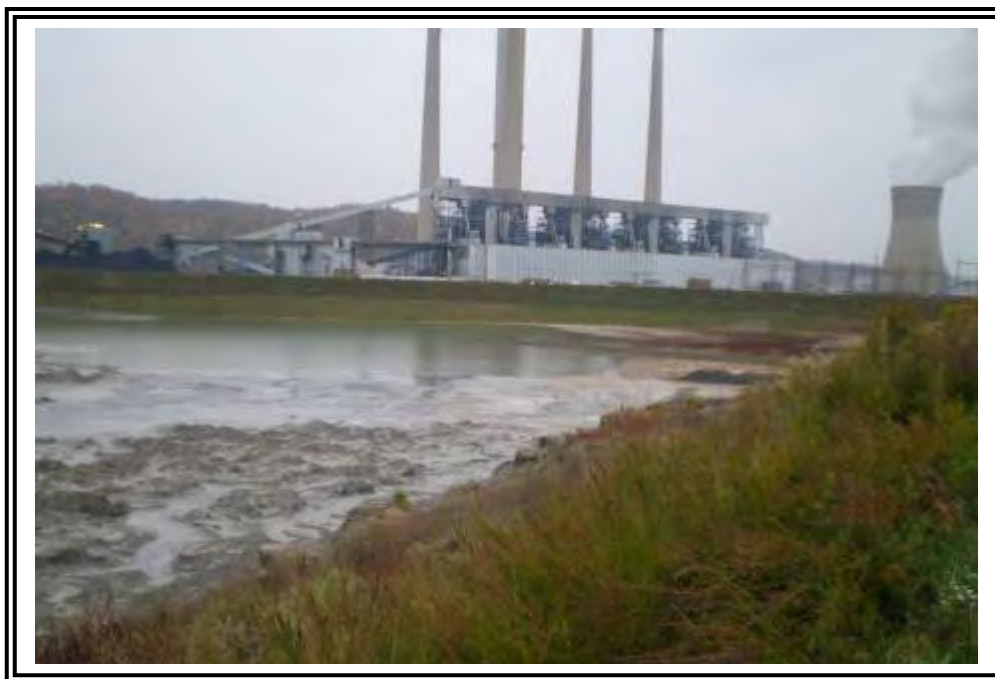
32

Looking south west along the upstream slope of the northern dike.

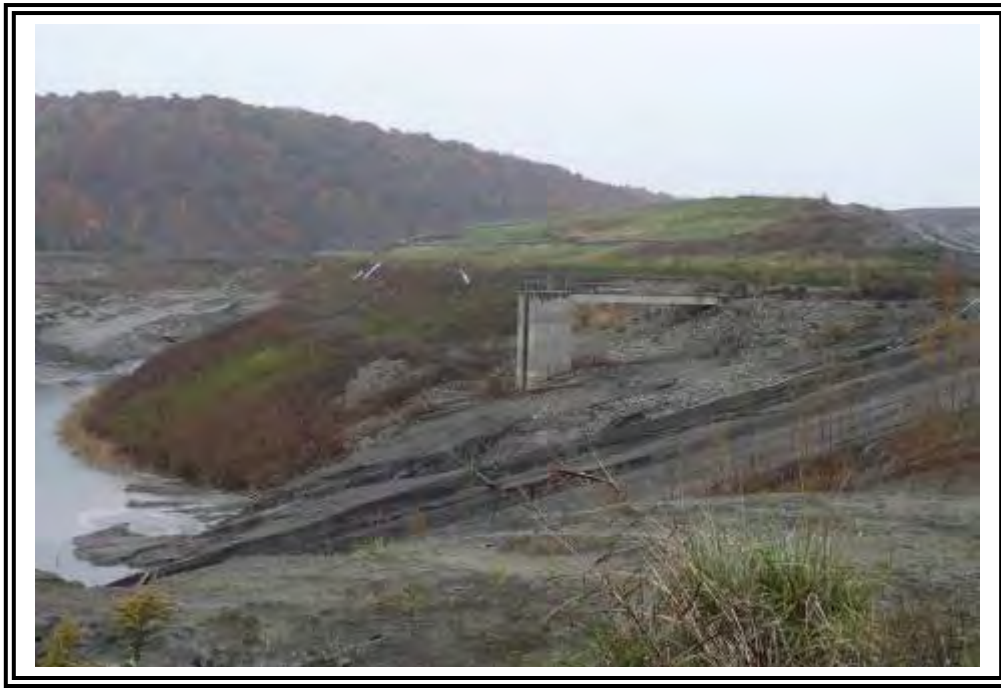
33

Looking north across pond back toward the outfall structure and truck ramp.

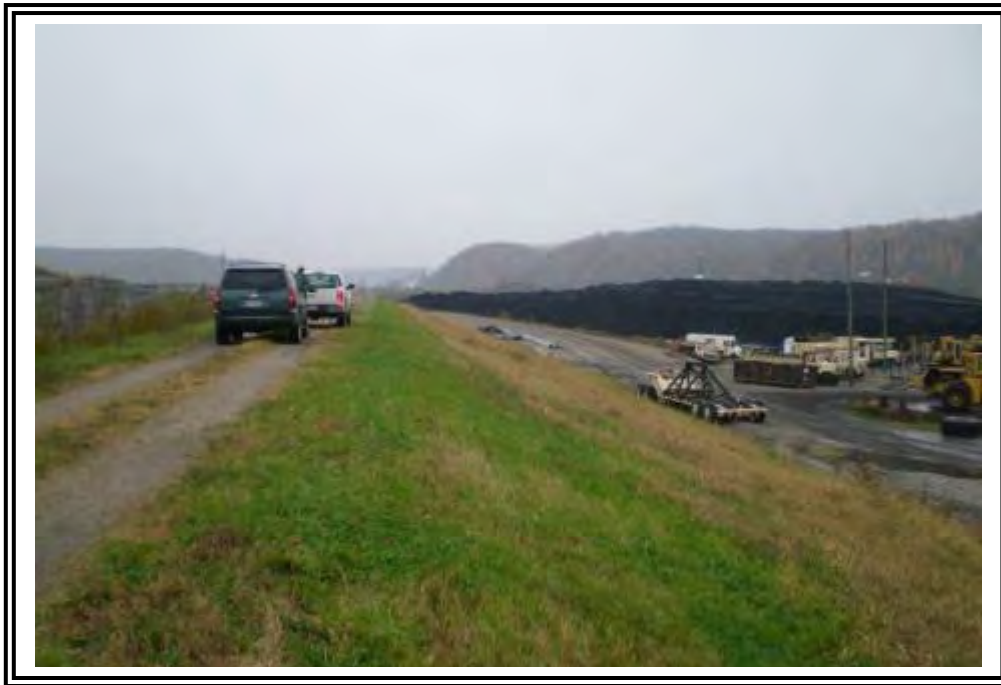
37

Looking southeast along downstream slope and crest of southwestern dike.

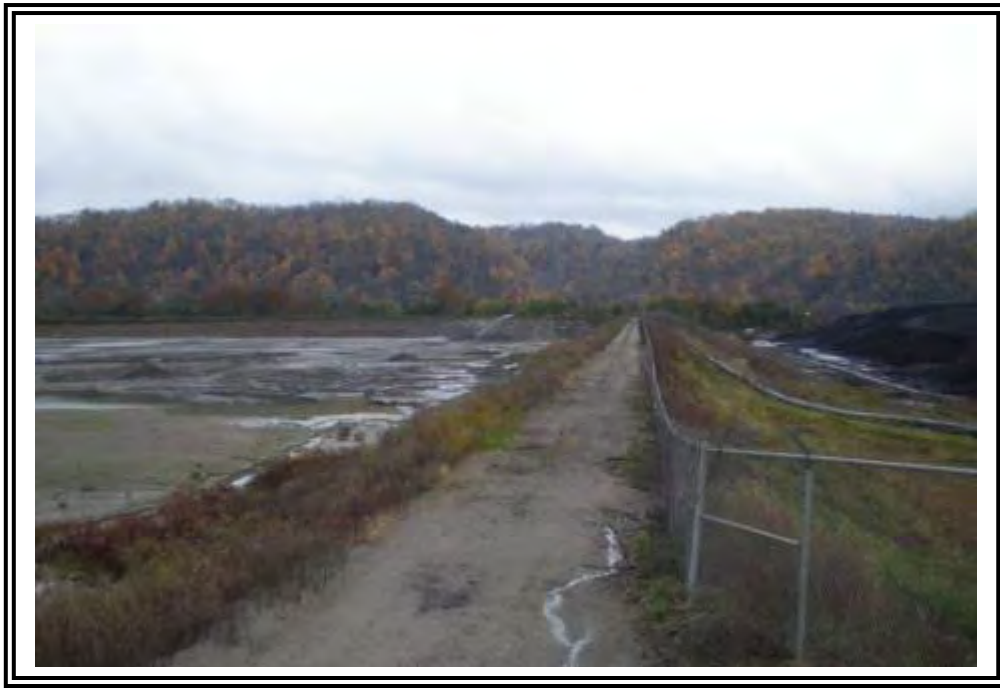
39

Looking south along the western dike crest of pond 3A.

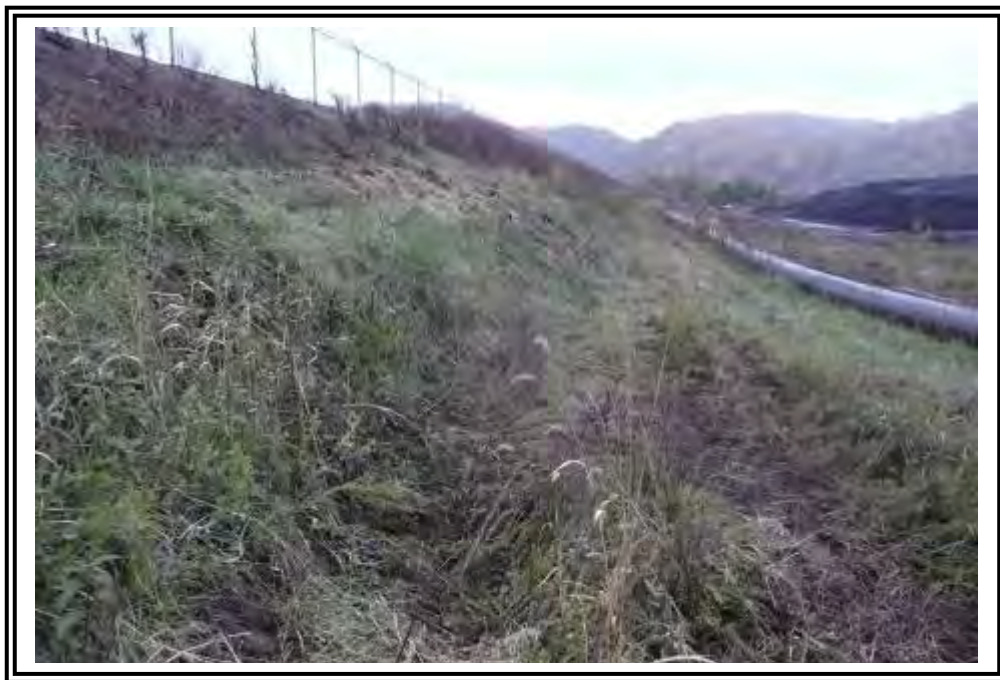
40

Looking south along the downstream slope at over-steepened area of the west dike of pond.  
Note sluice pipe near dike toe.

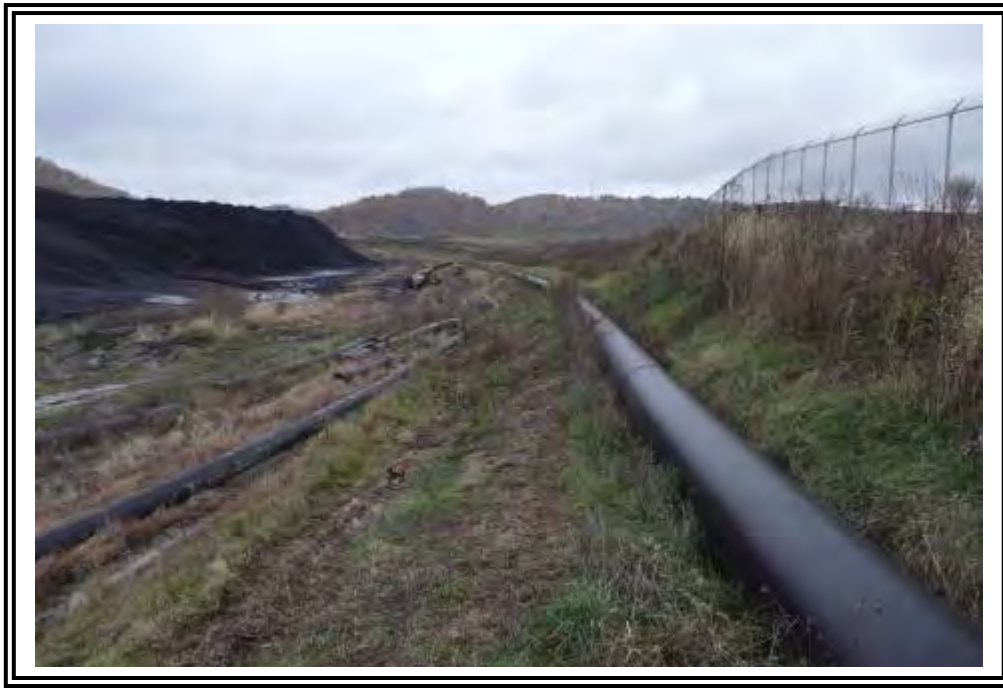
43

Looking north along the downstream slope of the west dike from the south end. Note sluice pipe on slope.

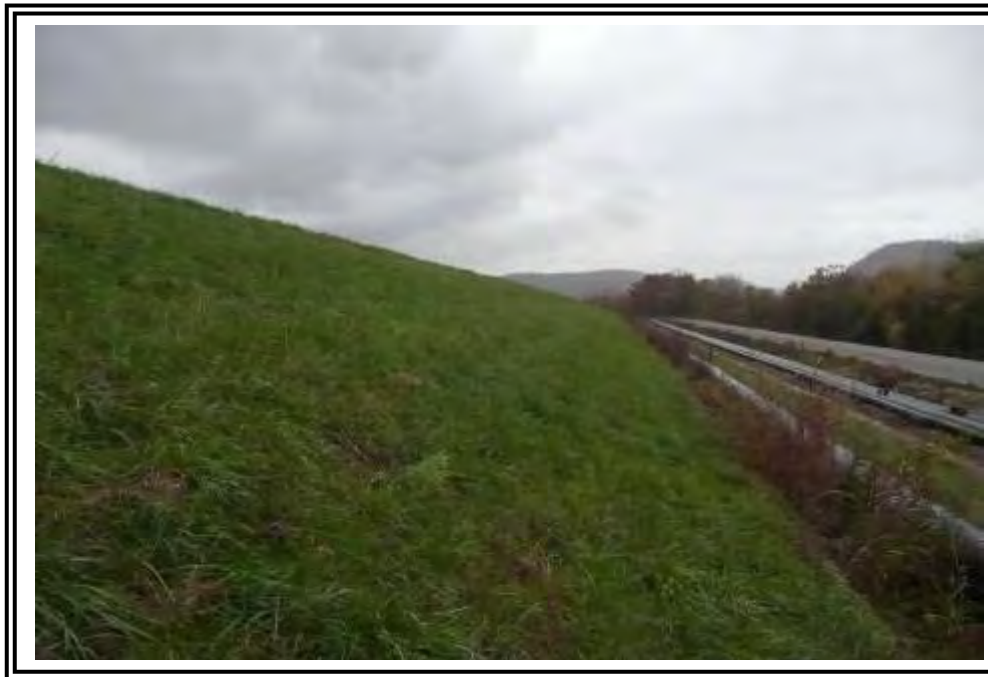
44

Looking east along the downstream slope of the south dike. Inactive sluice pipe in bench is visible at dike toe.

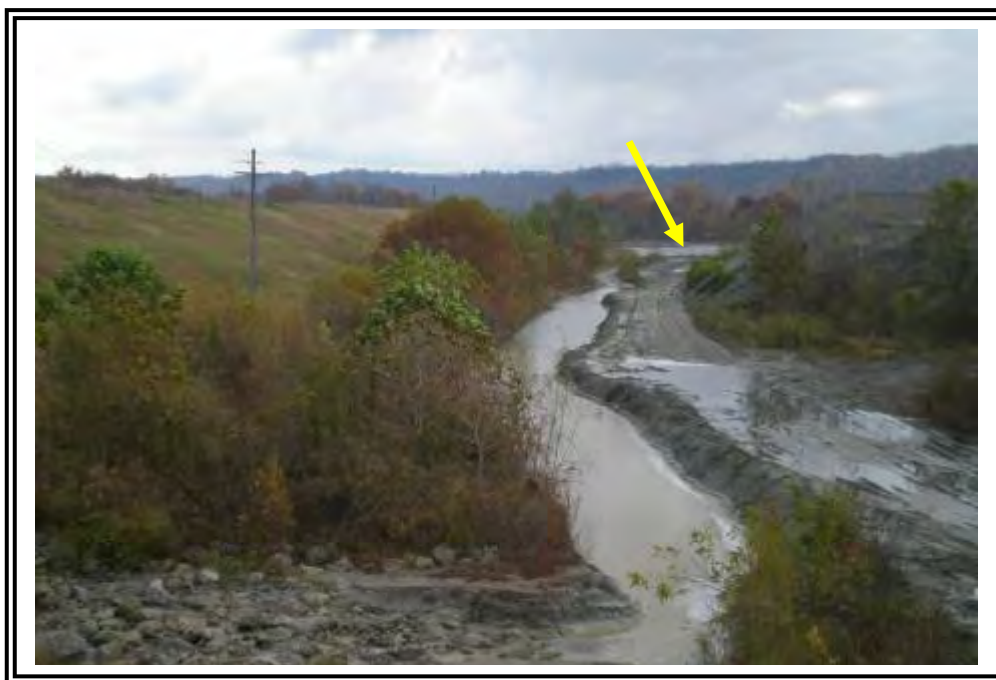
54

Looking east at the discharge channel that conveys effluent from Pond 10 and Pond 3A into Pond 6. Open water in Pond 6 is in distant background (see arrow).

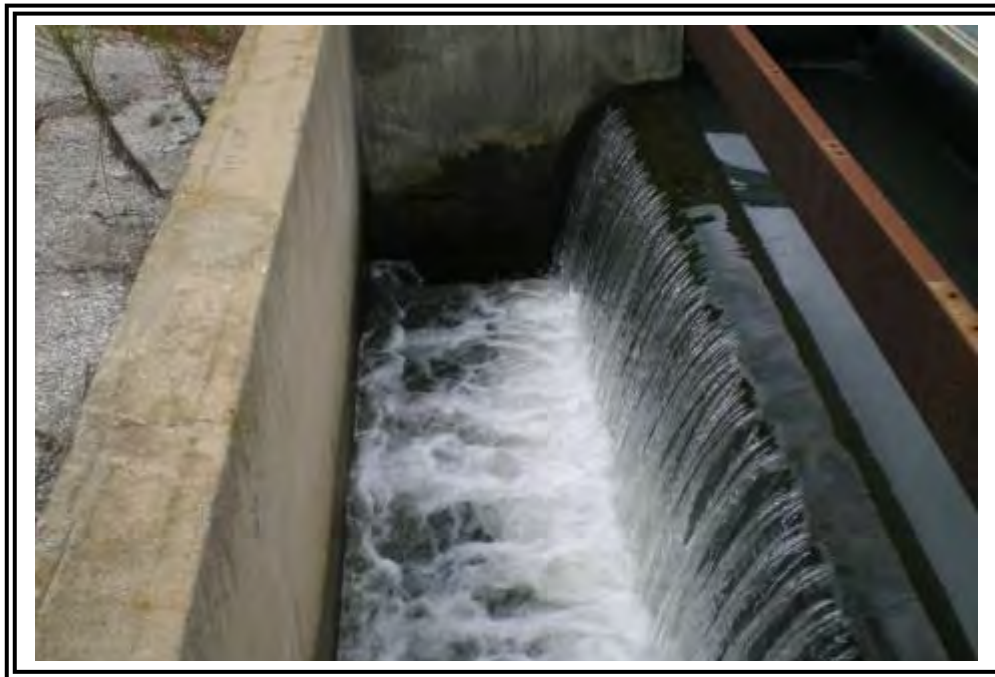
55

Pond 6 outfall structure at the northeast corner of the pond.

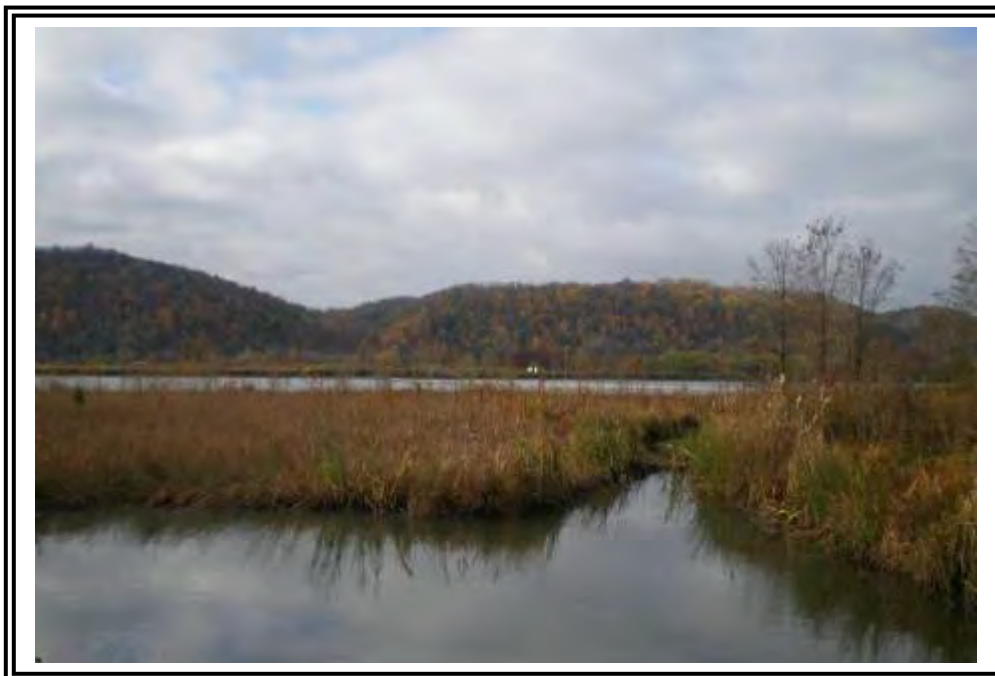
56

Inlet channel from Pond 7 into Pond 6

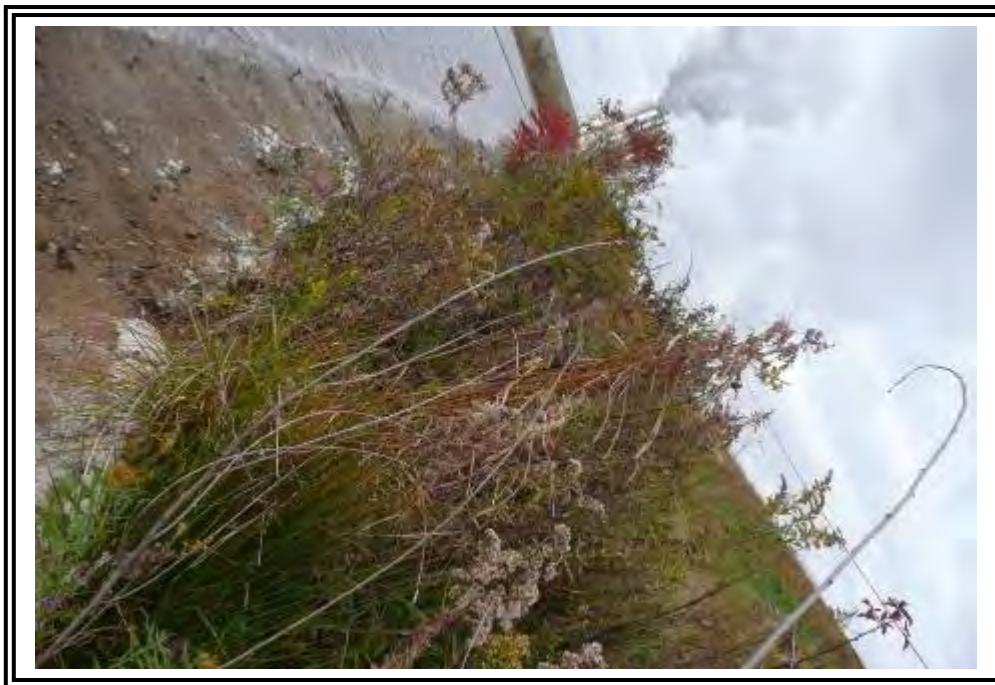
57

The north wall of the pond appears to be at the approximate foundation level for Landfill 11 (formerly Pond 8) as seen in Photo 61. This area is moderately to heavily vegetated with weeds, grasses, brush, and smaller trees (Photos 56, 57, 59, and 62). The pond level was down slightly during the site visit, and some beaching erosion was visible as noted in Photos 58 and 59. Standing water was also encountered intermittently in this area (Photo 60), but this was likely due to the recent rains, sheetflow runoff from the landfill, and the fairly flat topography in the area between Pond 6 and Landfill 11.

Moderate to heavy weedy, brushy vegetation on north dike of Pond 6, looking west.

Trees and brush should be cleared from all of the interior and exterior slopes of all the Ash Pond dikes. Heavy brush cover precludes observation of erosion, sloughing, rodent activity, or other causes of embankment deterioration.

Tree roots can allow for seepage of the retained water through the dikes, which could lead to internal erosion. Internal erosion could weaken the dikes and cause slope failures. Additionally, the uprooting of trees during storms can create large voids in the embankments that are then susceptible to erosion. Considering the progressive erosion that could occur during a storm which blows the tree over during heavy rains (i.e., hurricane type storm systems) progressive erosion could potentially result in enough loss of soil from the dike to create an unstable situation, which if failure occurs could result in a release of ash.

CHA recommends that vegetation be cut on a regular basis ensure that adequate visual observations are being made by during routine inspections.

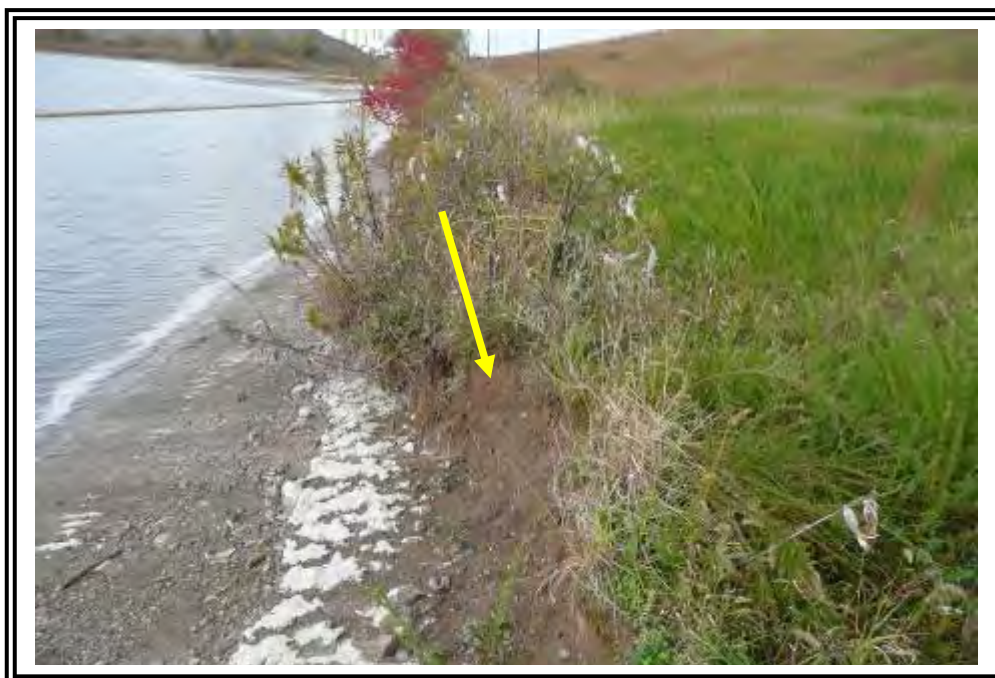
58

Looking west at beaching erosion (arrow) on north wall of Pond 6. Recent high water level is evident from deposited ash in picture.

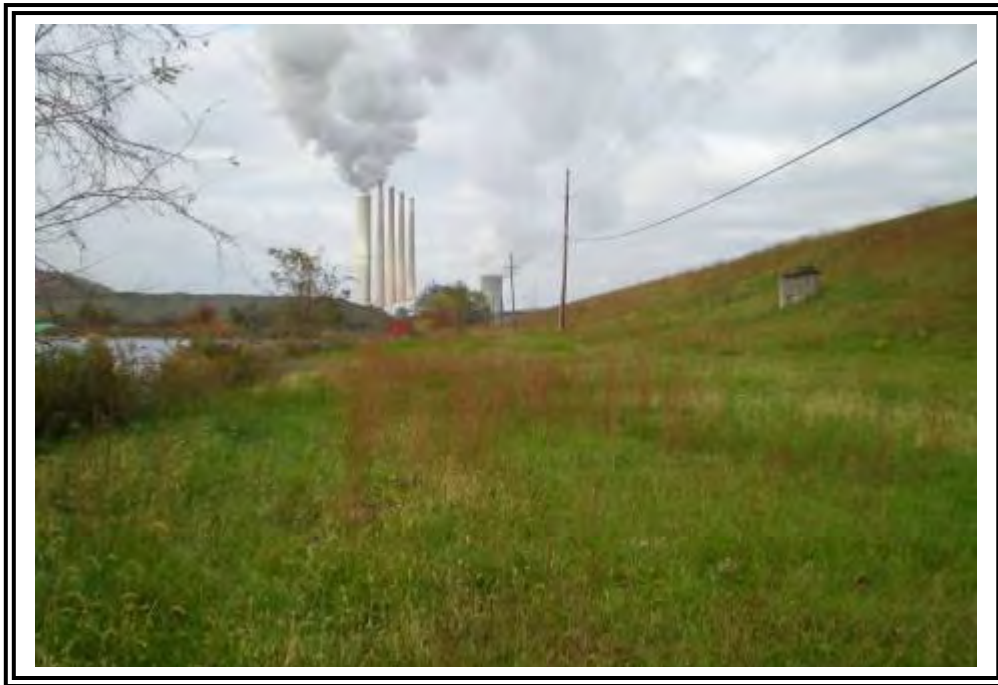
61

Looking west along the northern side of Pond 6. Landfill 11 is off the right side of photo.

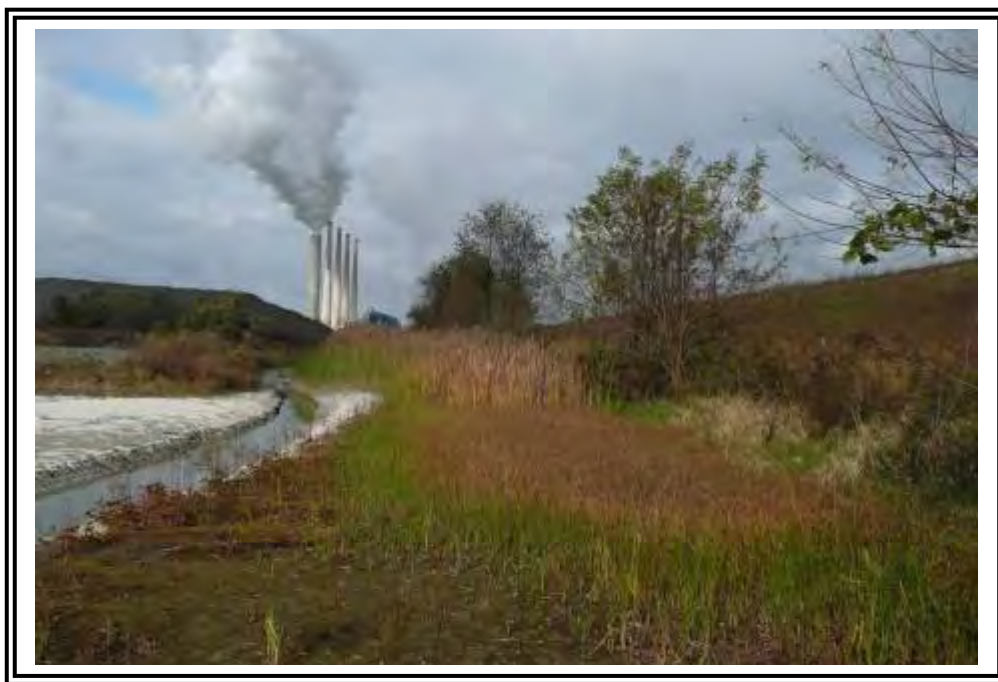
62

Looking west along the northern side of Pond 6 from a point farther west than shown in Photo 61.

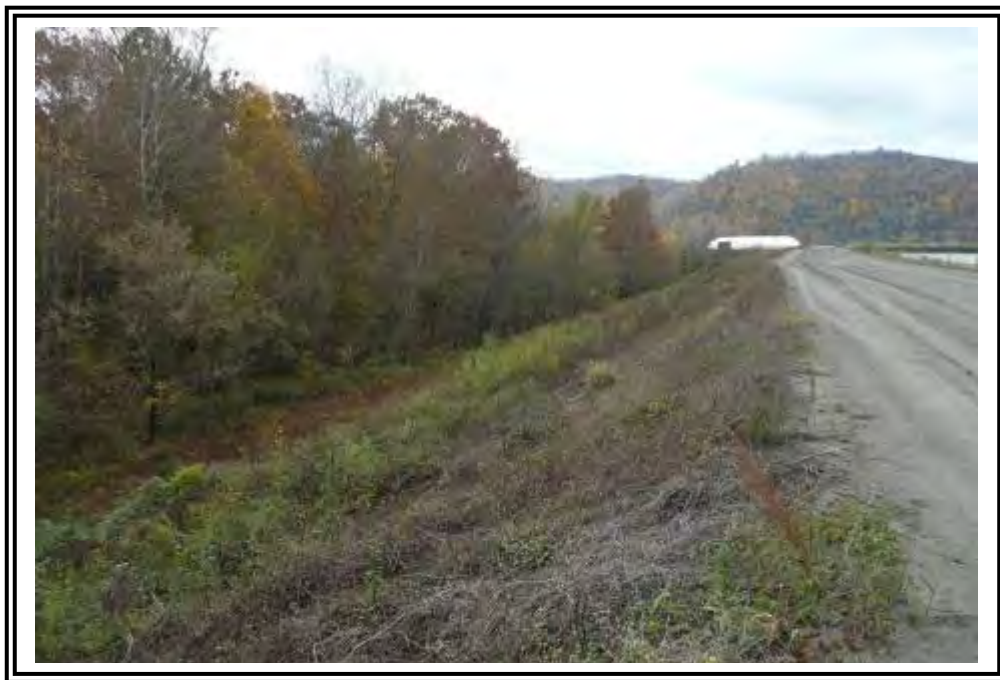
64

Looking south along the downstream slope of the east dike of Pond 6.

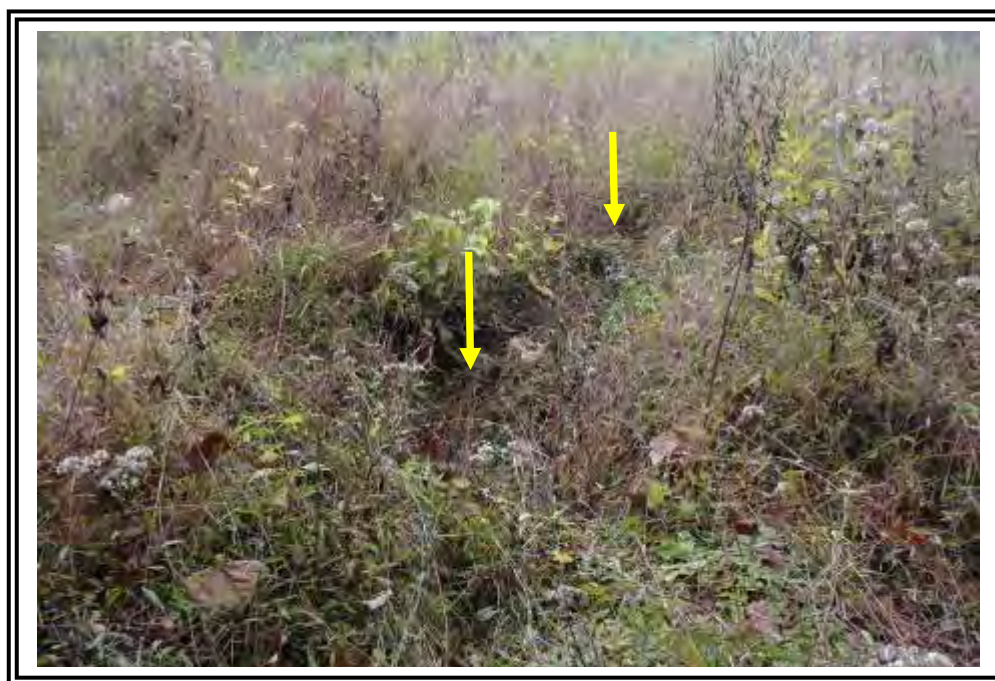
66

Vegetated erosion rill toward the center of the east dike of Pond 6  
approximately 1.0 to 2.0 feet deep.

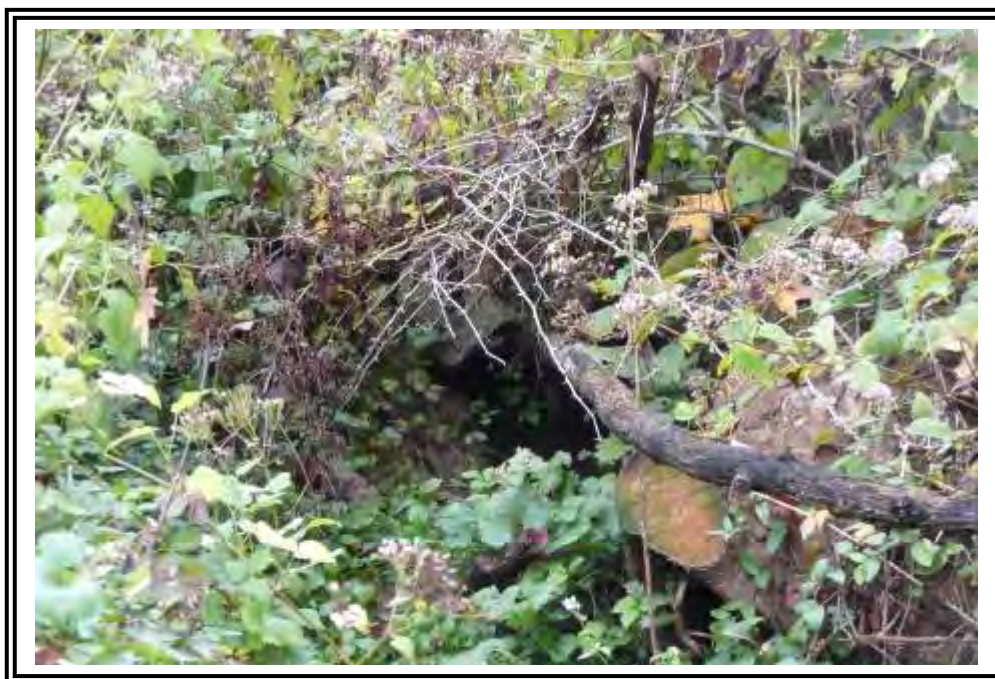
68

Close up of a possible rodent burrow or animal cave in the dense vegetation on the  
downstream slope of Pond 6 east dike.

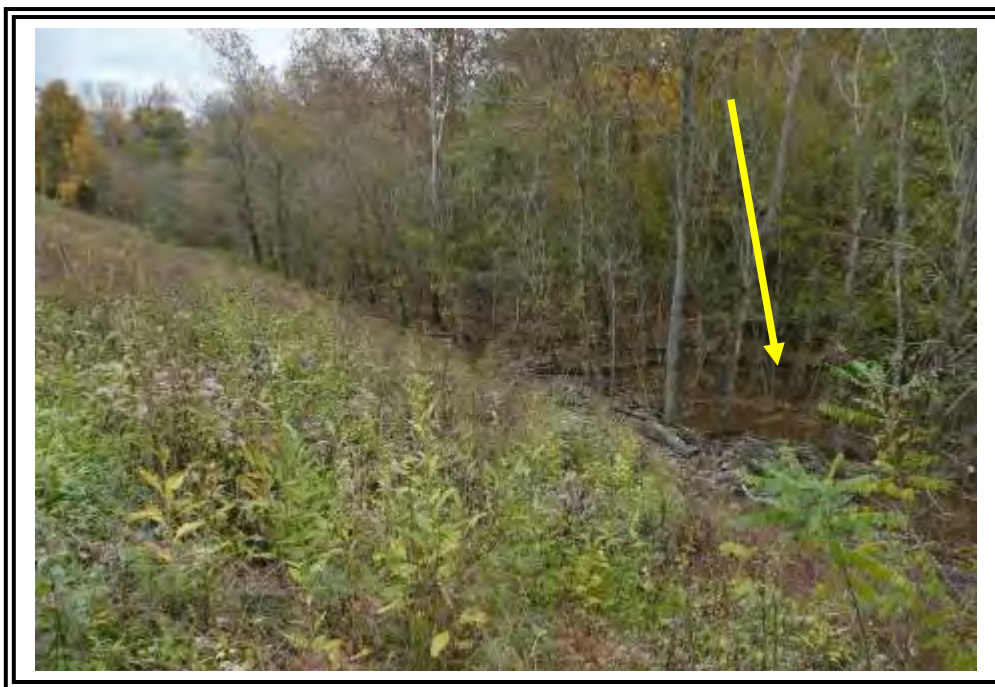
69

Downstream east dike slope of Pond 6, looking north from mid-slope.  
Creek area at toe on right side of photo (arrow).

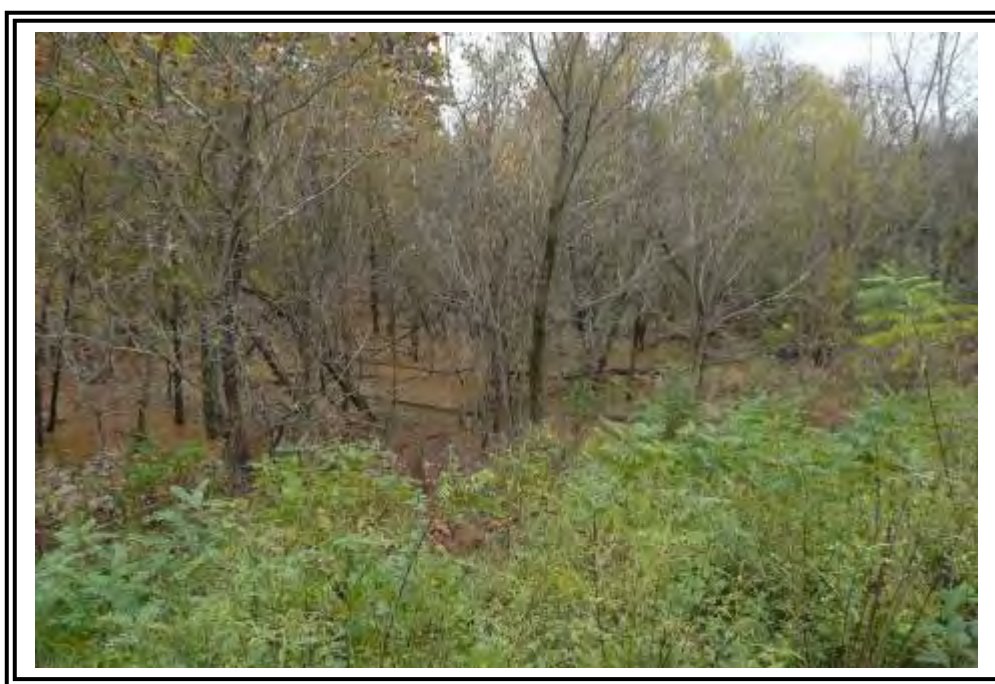
70

Another view of water in creek backing up against downstream toe on east dike of Pond 6.

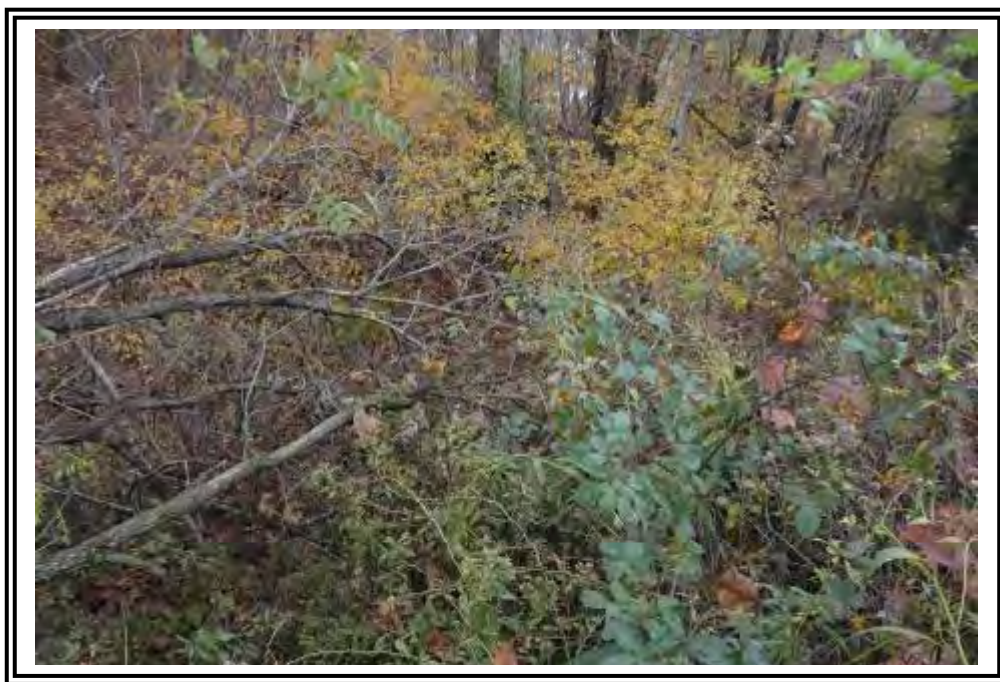
74

Dense to very dense vegetation on the downstream slope of Pond 7/7A east dike.

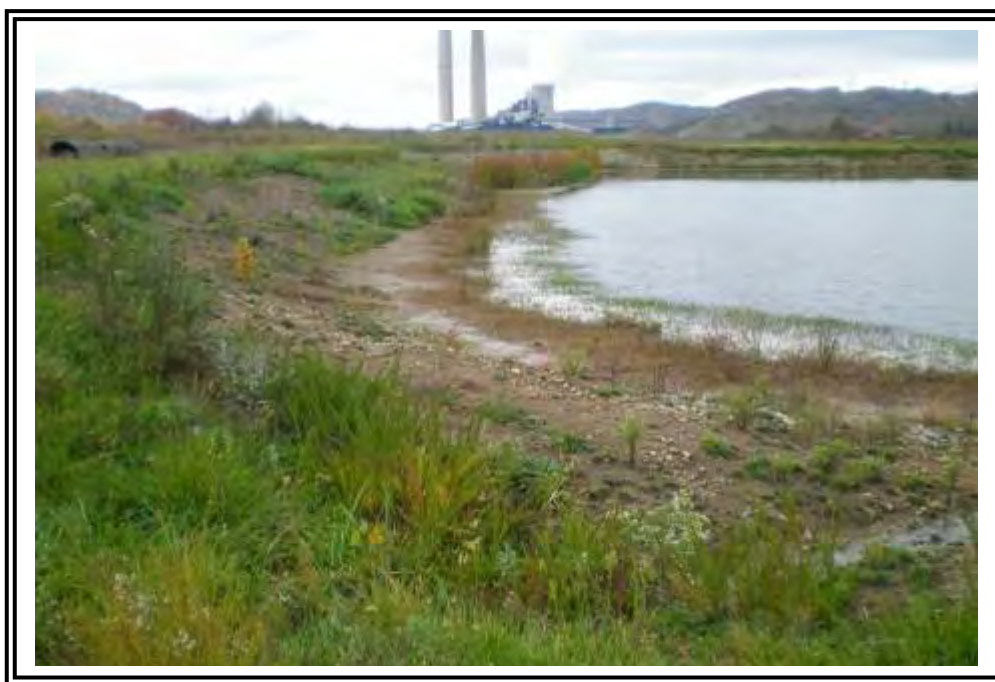
78

Looking west along south side of Pond 7A and filled in portion of Pond 7.

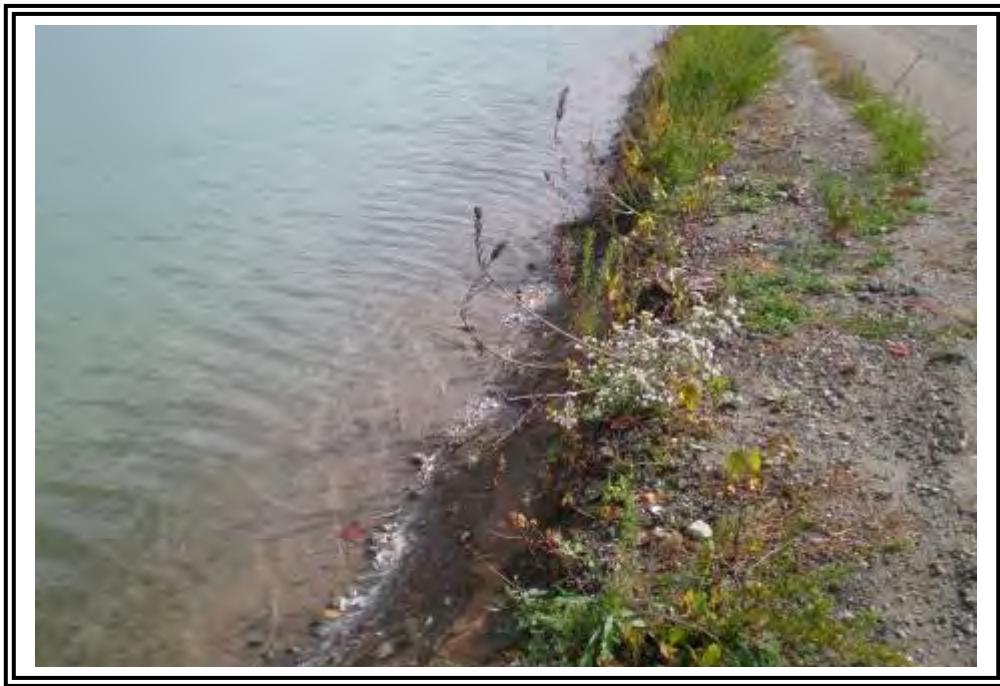
86

Close up of upstream slope of Pond 7 south dike.

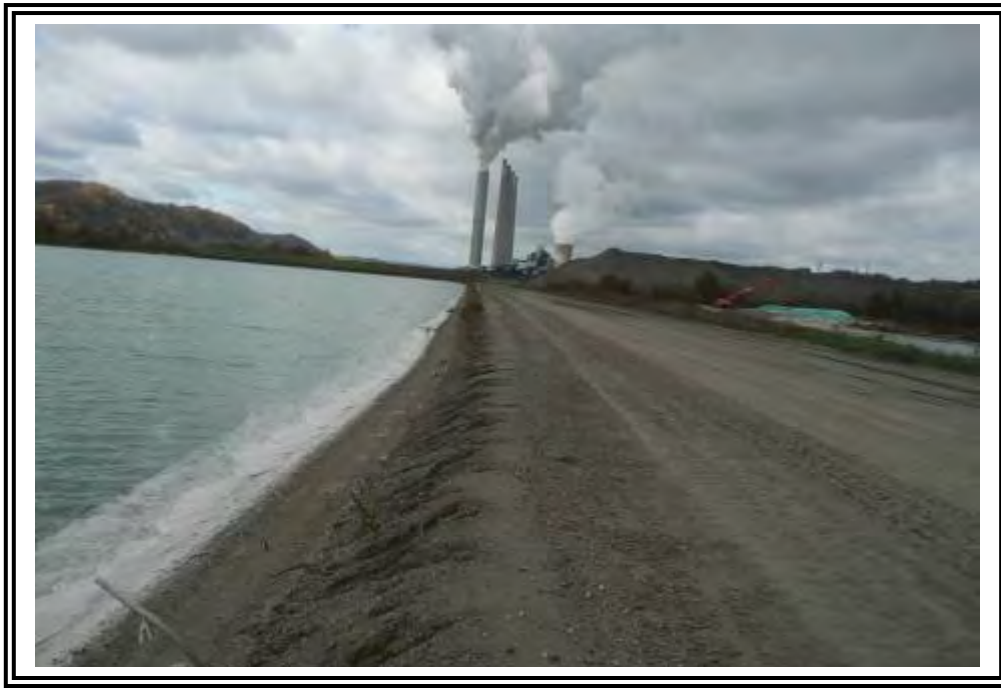
97

Looking west along the separator dike between Pond 7 (left) and Pond 6 (right).

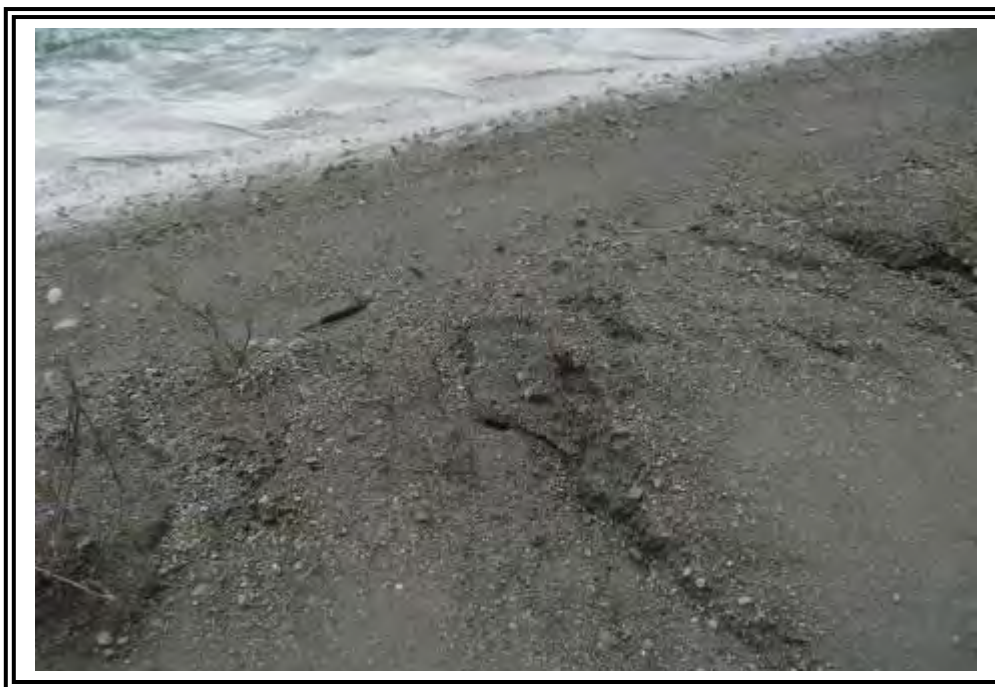
99

Erosion rills on Pond 7 side of separator dike between Pond 6 and Pond 7/A.

Erosion rills and subsequent loss of grass cover were observed on multiple embankment slopes of the Ash Ponds as discussed in Sections 2.2.1 and 2.3.1. Thinning and loss of grass cover due to concentrated flow was noted on the embankment slopes. CHA recommends repairing these area by filling all rills with compacted material and re-seeding to establish grass where applicable (i.e. exterior embankment slopes).
